Lake Conjola

Summary of OH&S Treats and Risks Assessment

February 2019

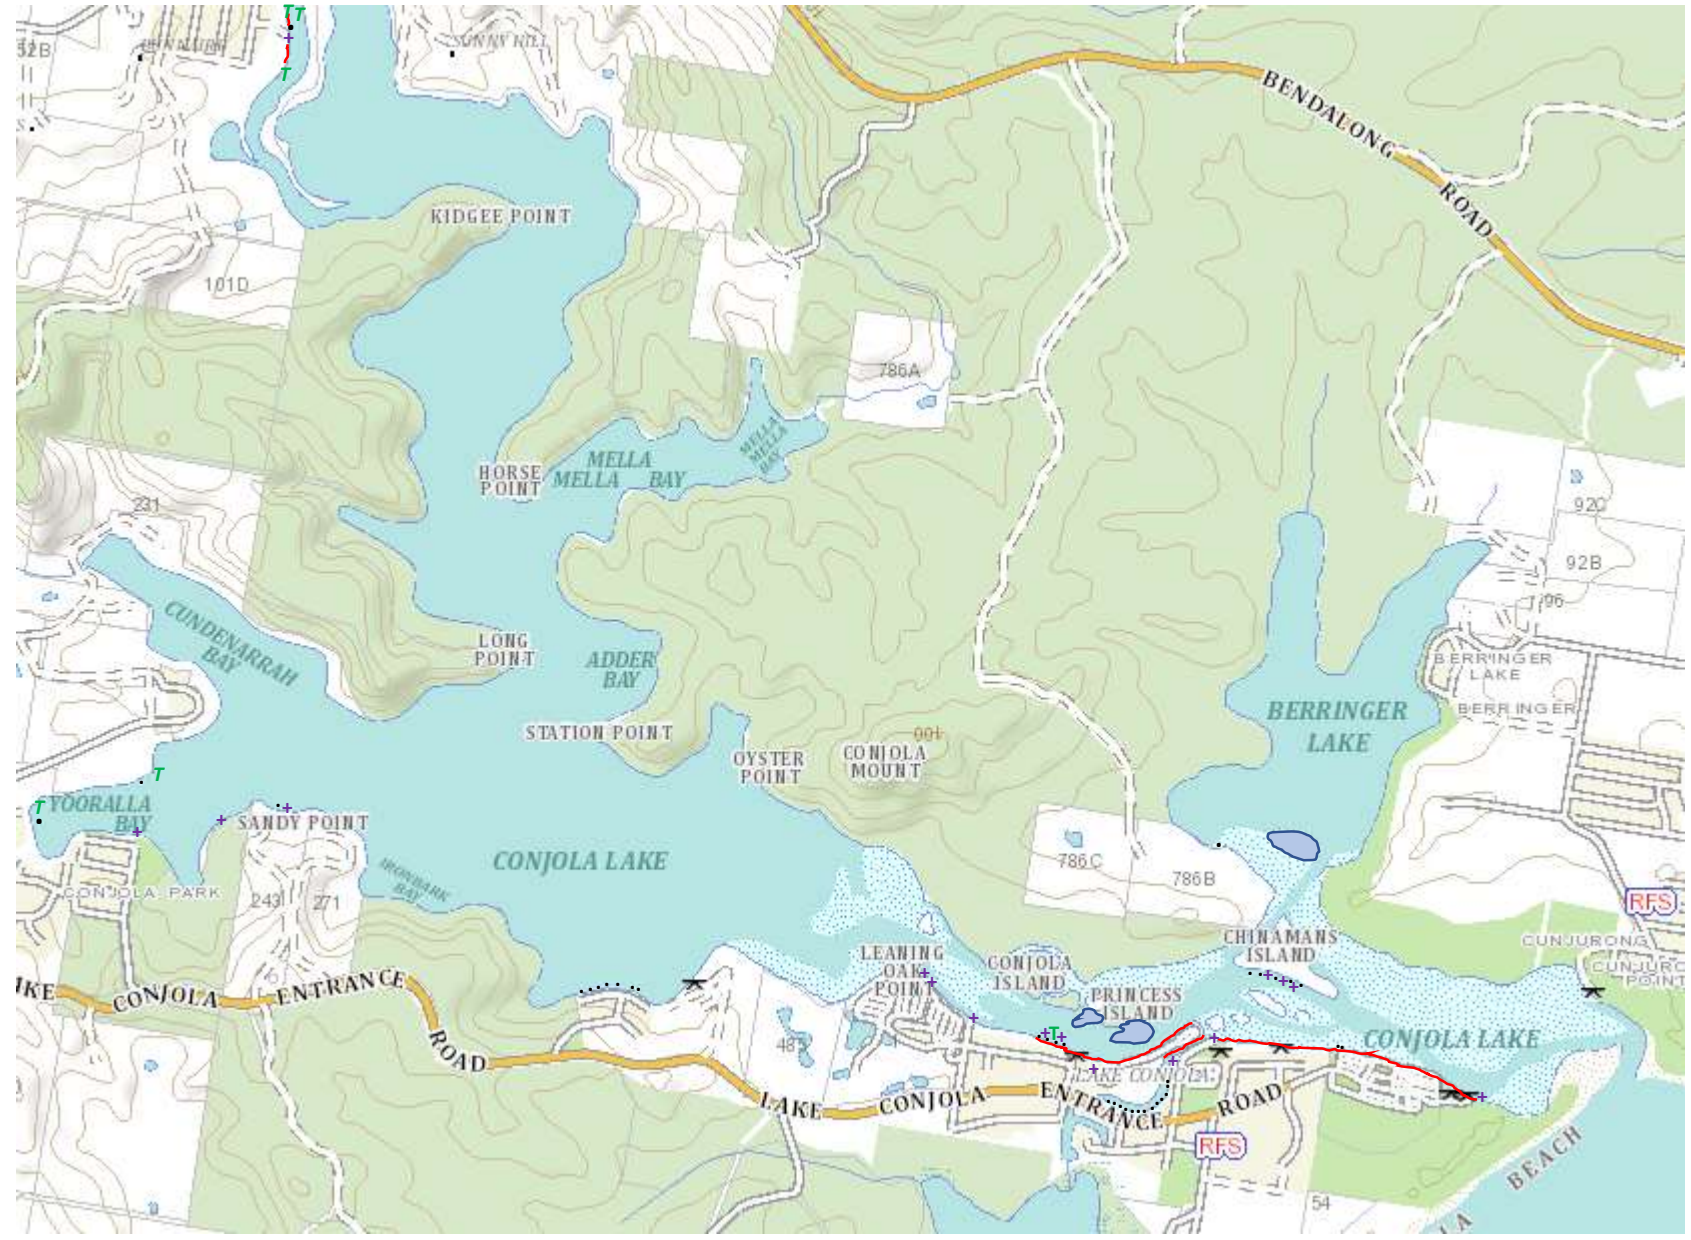
Foreshore Threats & Risks

- ... 5.907km of public and private foreshore partially or fully inundated
- ... Above includes 1.53km of partially or fully submerged rock seawalls
- ... Beach profile throughout entire Lake (with the exception of Killarney Point) submerged with no easy access
- ... Increased concentration of water skiing / wakeboarding craft at this location
- ... 37 public and private jetties/slipways partially or totally submerged
- ... 12 public and private boat ramps partially or fully submerged – all slippery from alga and/or wave overtopping
- ... 2 remnant oyster lease structures partially submerged in navigable channels
- ... 6 recently fallen significant trees added to waterway
