**LAKE CONJOLA ENTRANCE MANAGEMENT
DREDGING WORKS
REVIEW OF ENVIRONMENTAL FACTORS**

Report No. MHL 1161

**NSW Department of Public Works and Services
Manly Hydraulics Laboratory**

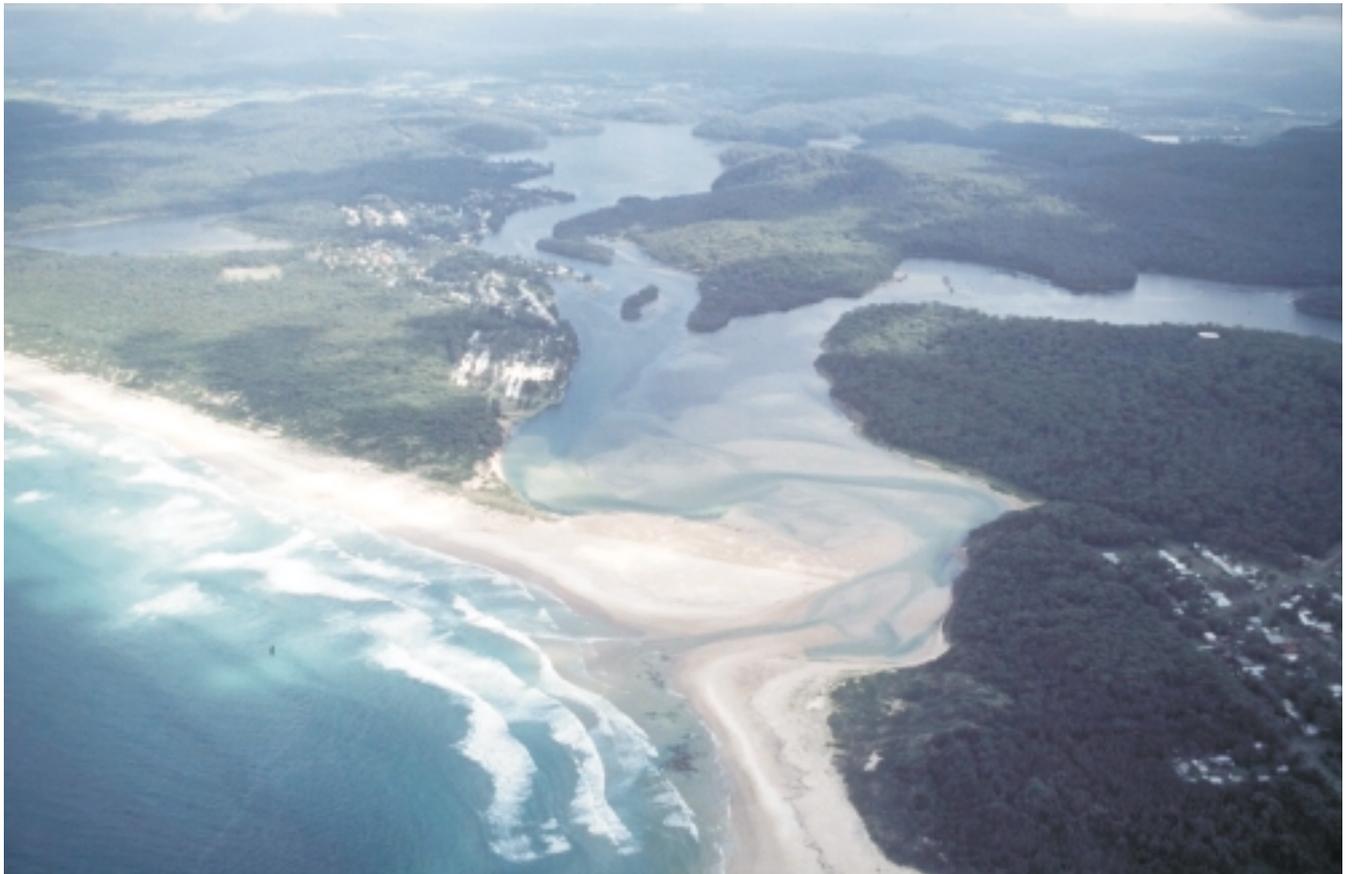
Figure
1.1

Lake Conjola is a coastal lake located about 50 km south of Nowra on the NSW south coast (Figure 1.1). The lake has a surface area of approximately 4.3 km² and a catchment area of 145 km². Lake Conjola is classified as a predominantly open lake and historically has remained open for 62% of the time. A shallow sandy inlet some 3 km long separates the main lake, which has water depths up to 10 m, from the ocean. The inlet itself is shallow with extensive intertidal muddy sand flats and an average channel depth of the order of 1 m (Figures 1.2, 1.3).

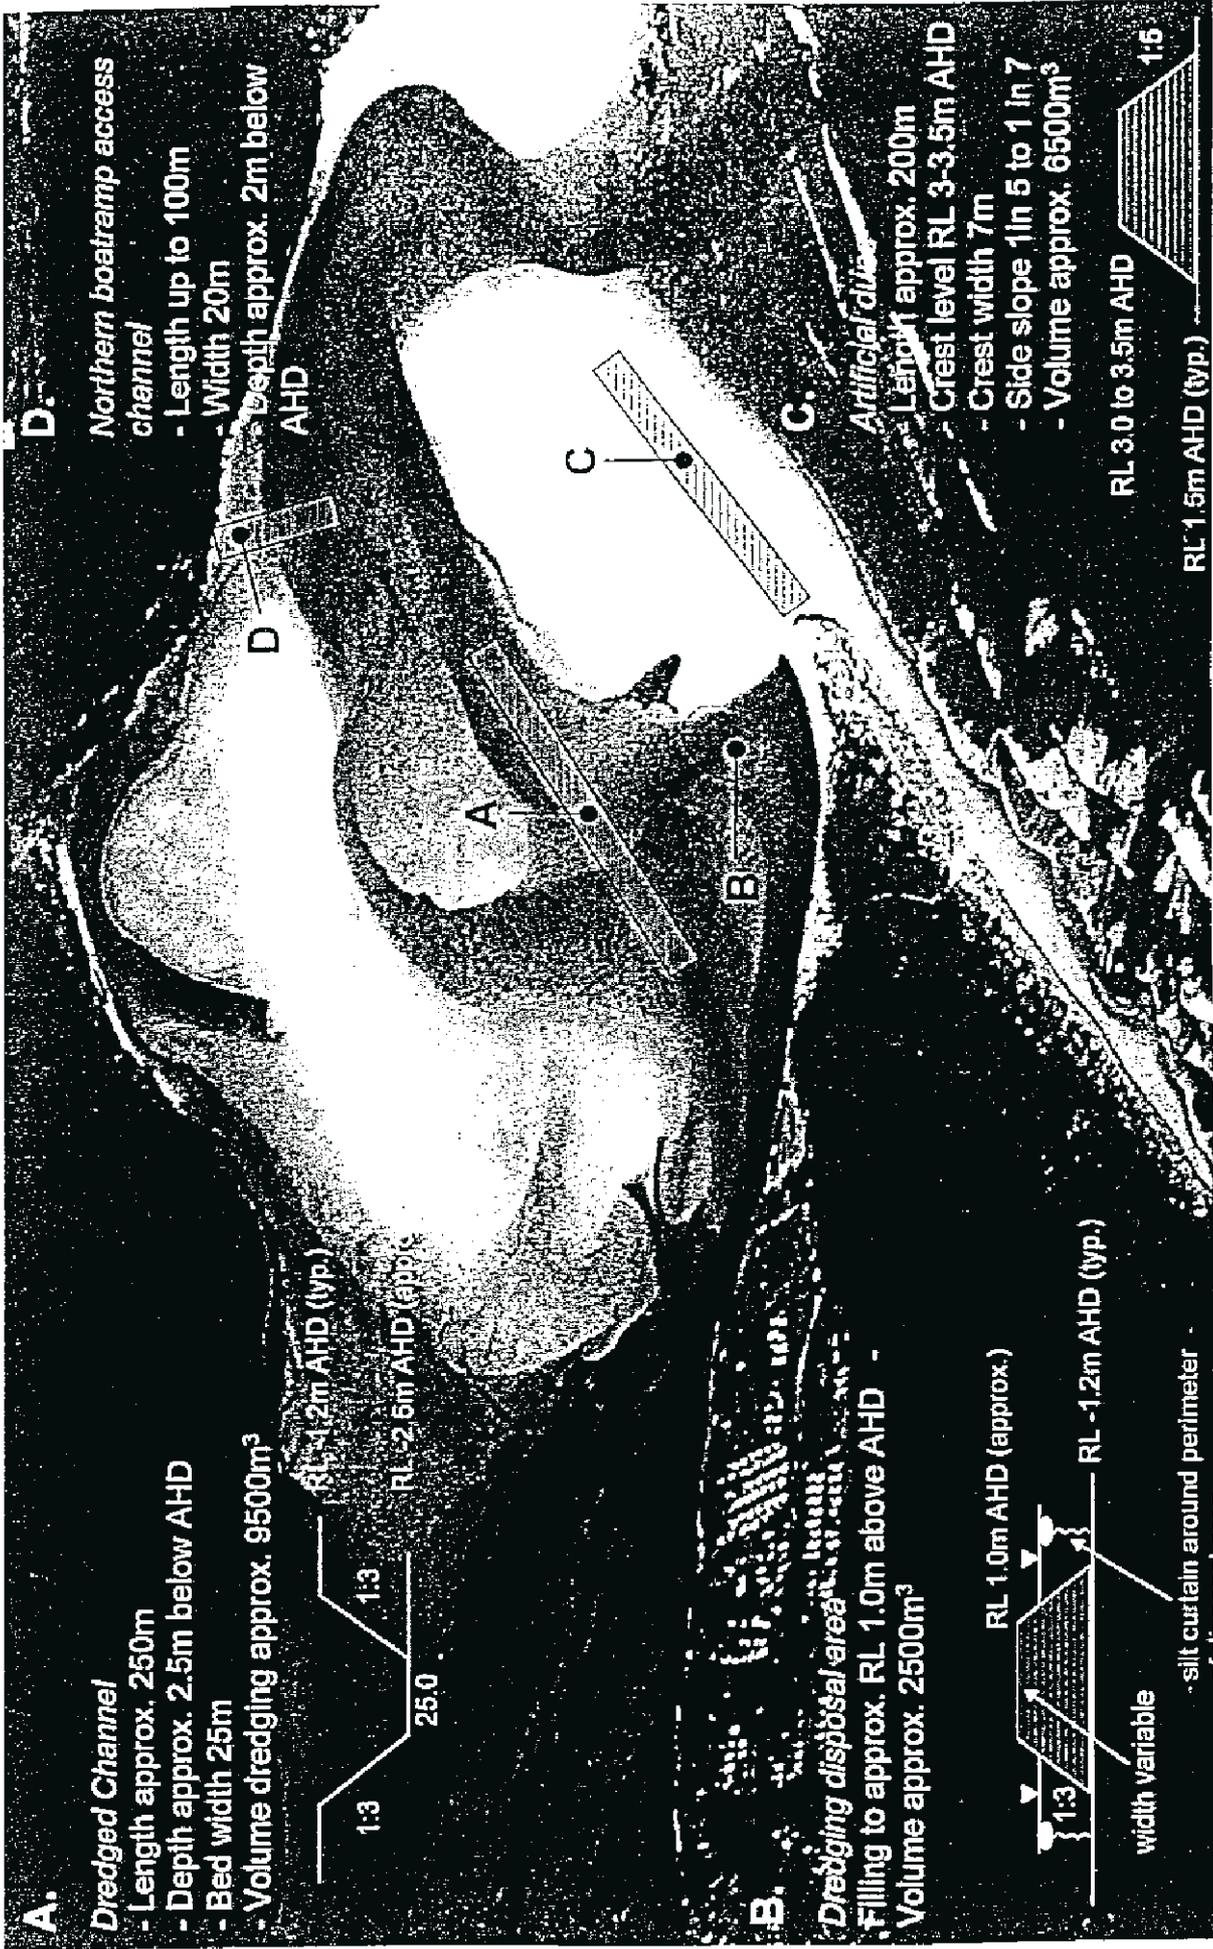
FIGURE 1
 PROPOSED WORKS

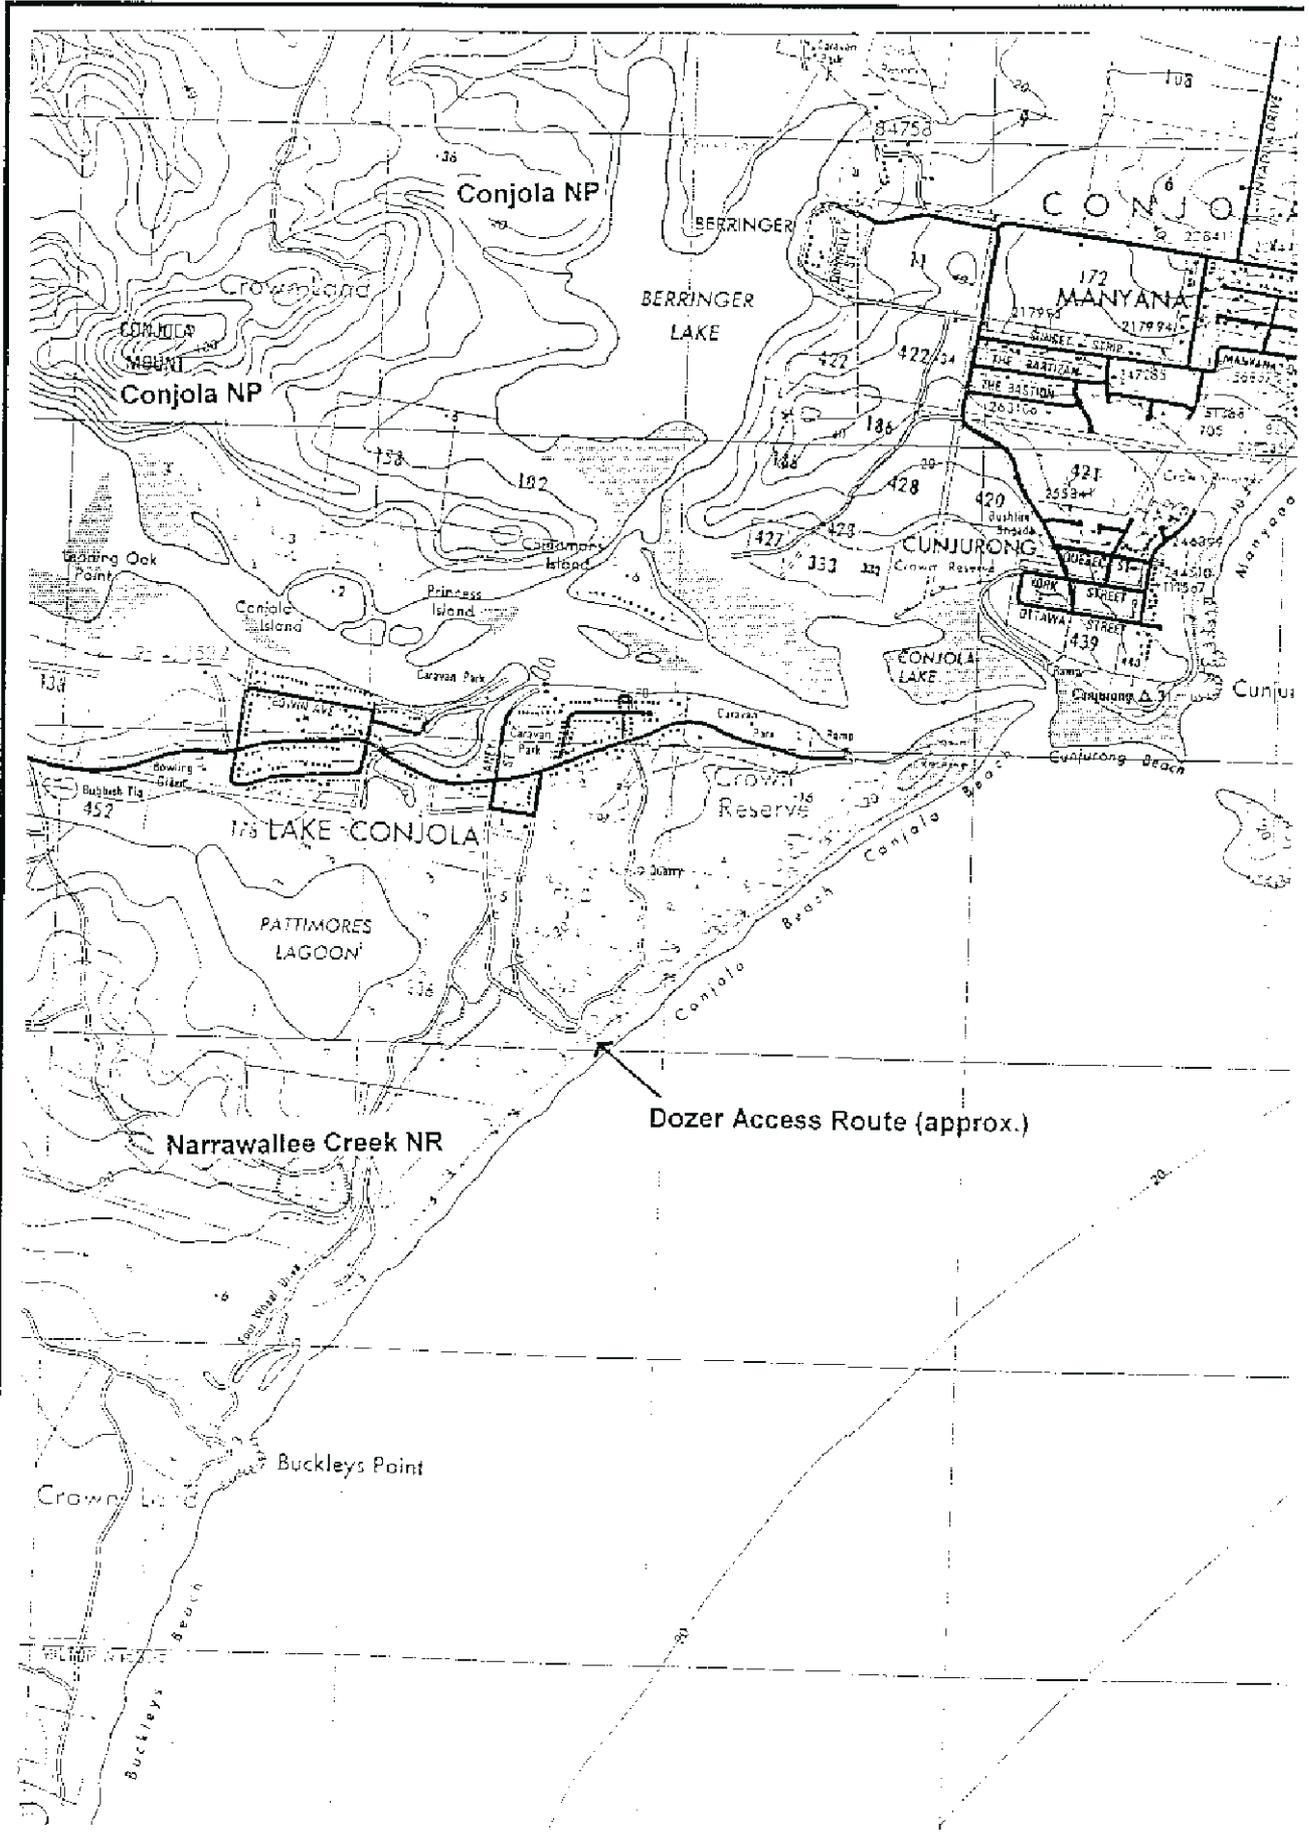
Figure 2 shows the general location of Conjola Lake and the surrounding features. Most of Conjola Lake is surrounded by Conjola National Park. Narrawallee Creek Nature Reserve, including Pattimores Lagoon, is to the south of Lake Conjola village.

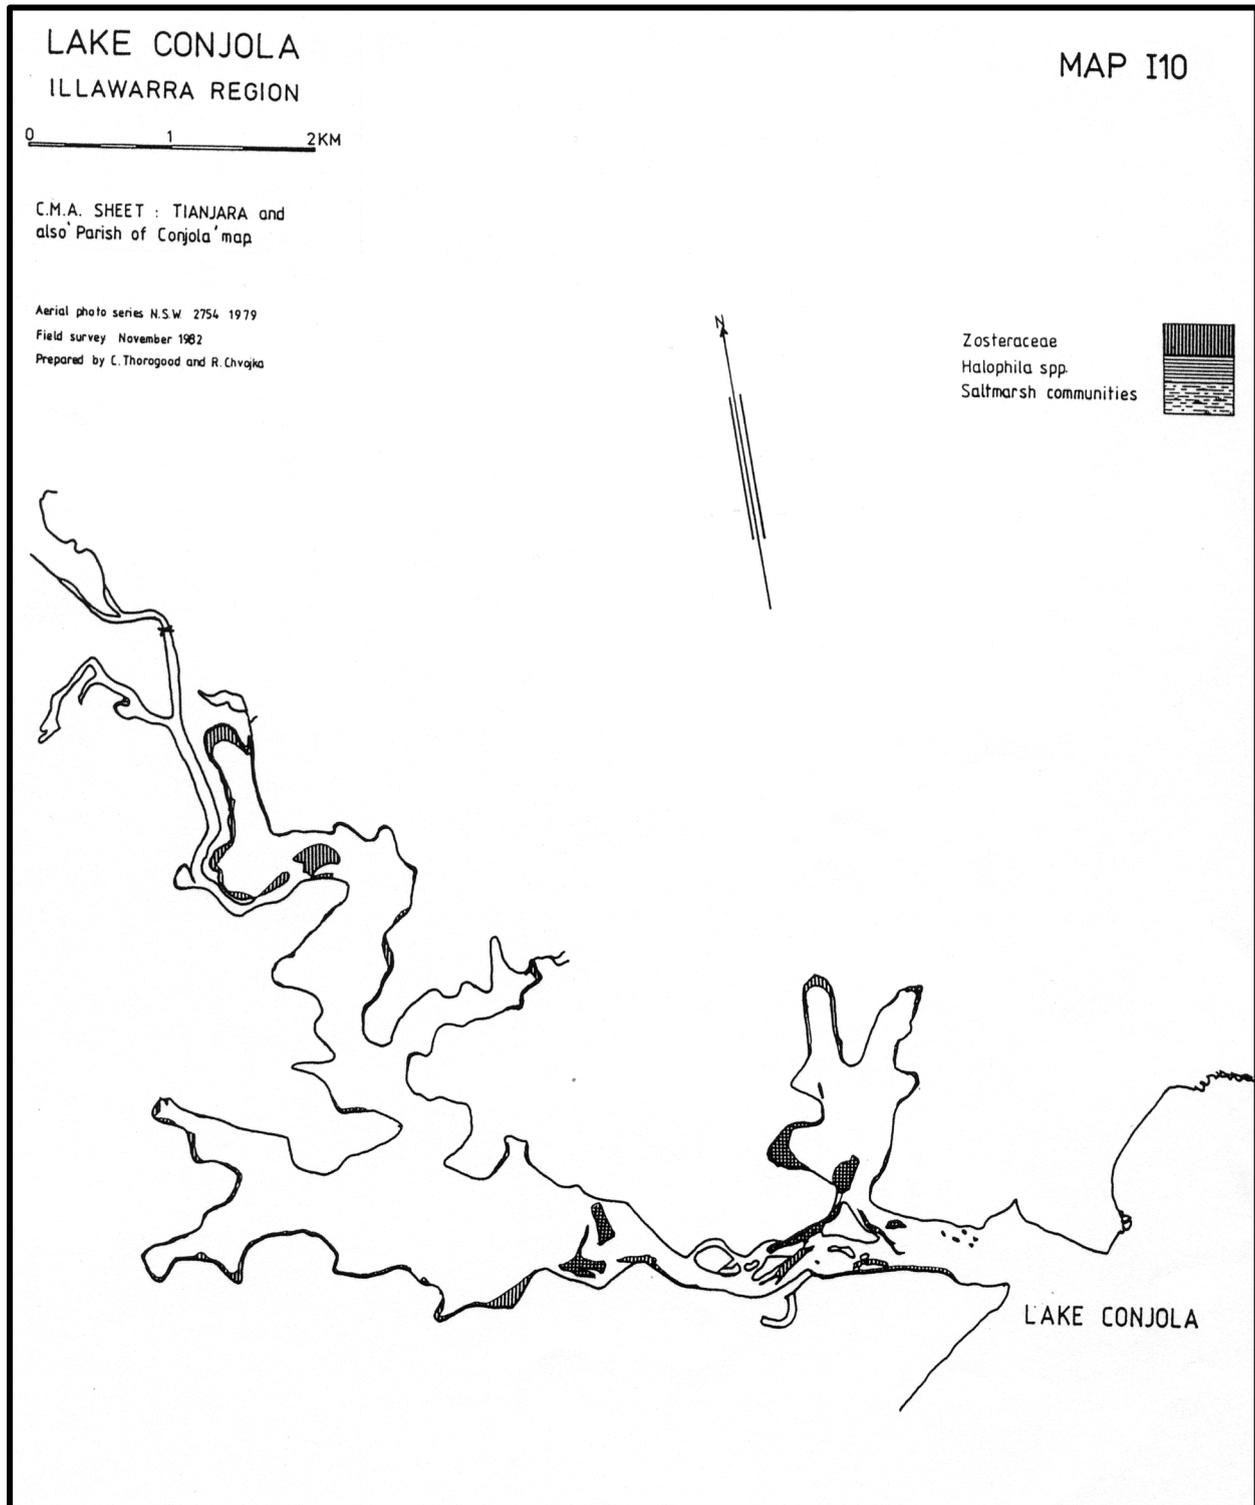
Figure 1: Seagrass distribution in Lake Conjola reproduced from West *et al.*, 1985.

Figure 1: Seagrass distribution in Lake Conjola reproduced from West *et al*, 1985

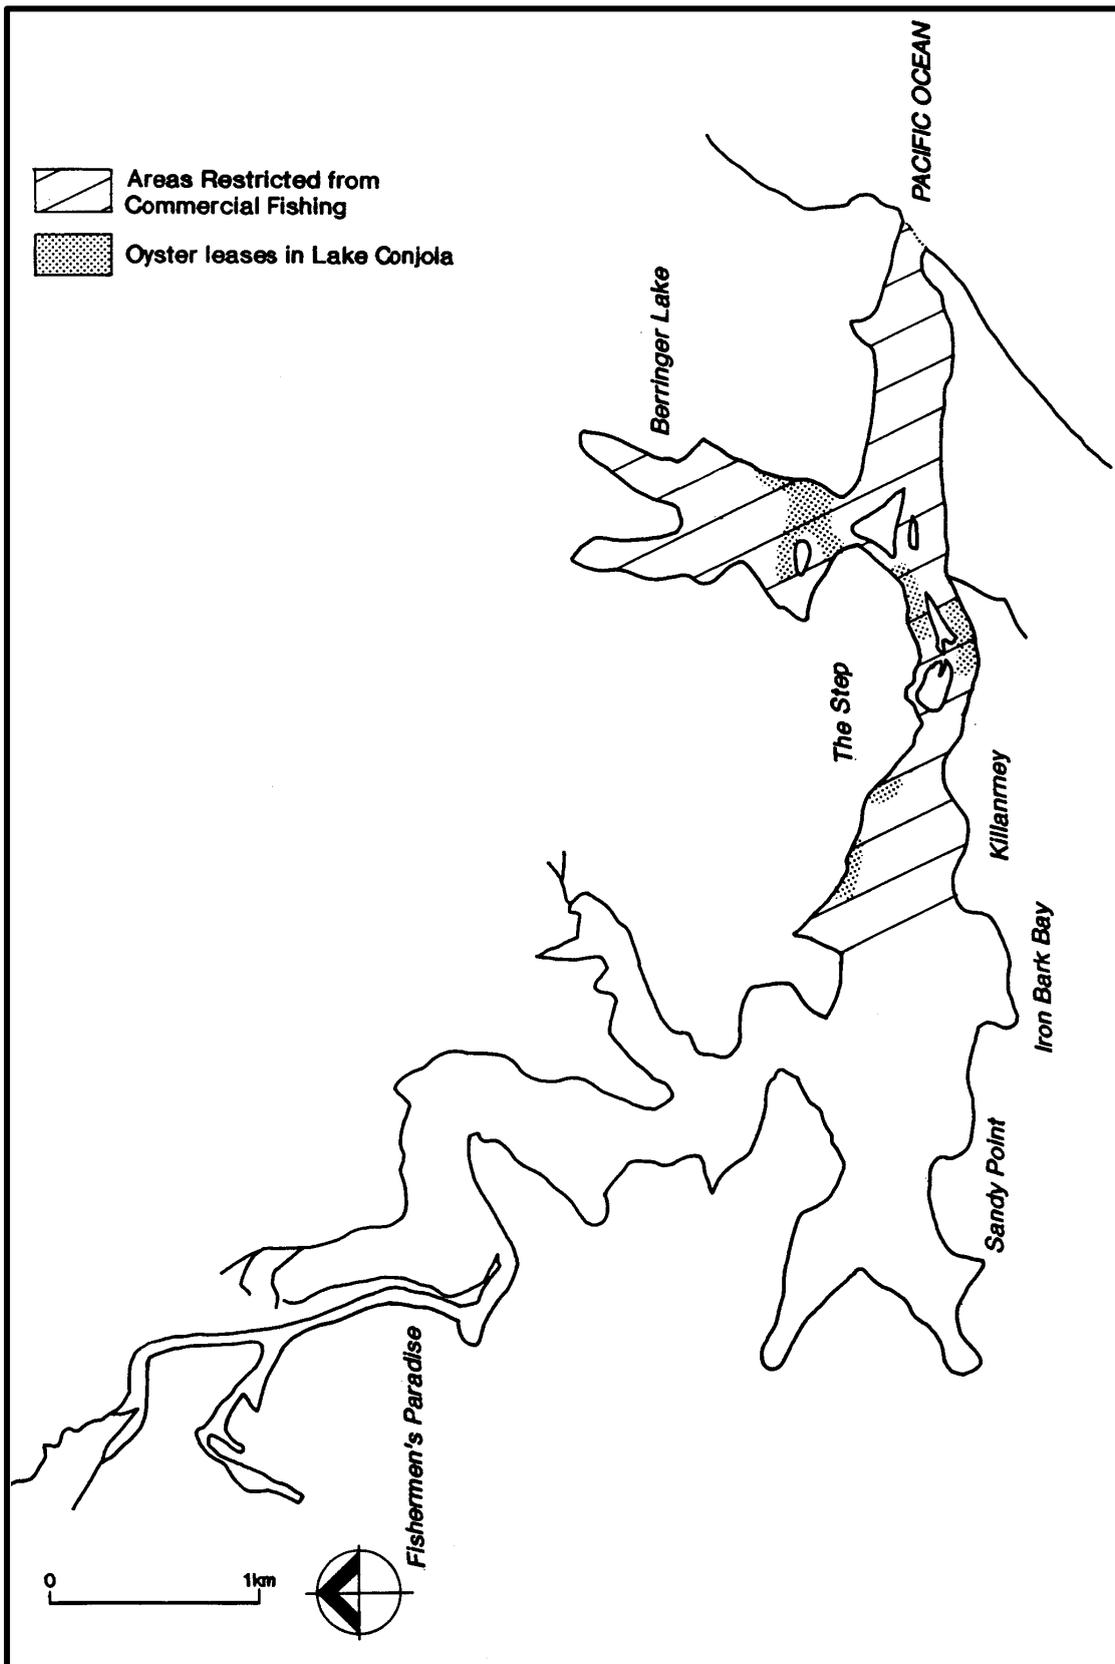
Figure 2: Restricted areas for commercial fishing and oyster leases in Lake Conjola.

Figure 2: Restricted areas for commercial fishing and oyster leases in Lake Conjola.
