SHOALHAVEN CITY COUNCIL

LAKE CONJOLA ENTRANCE STUDY

**Issue No. 2
MAY 1999**

**Patterson Britton
& Partners Pty Ltd**
consulting engineers

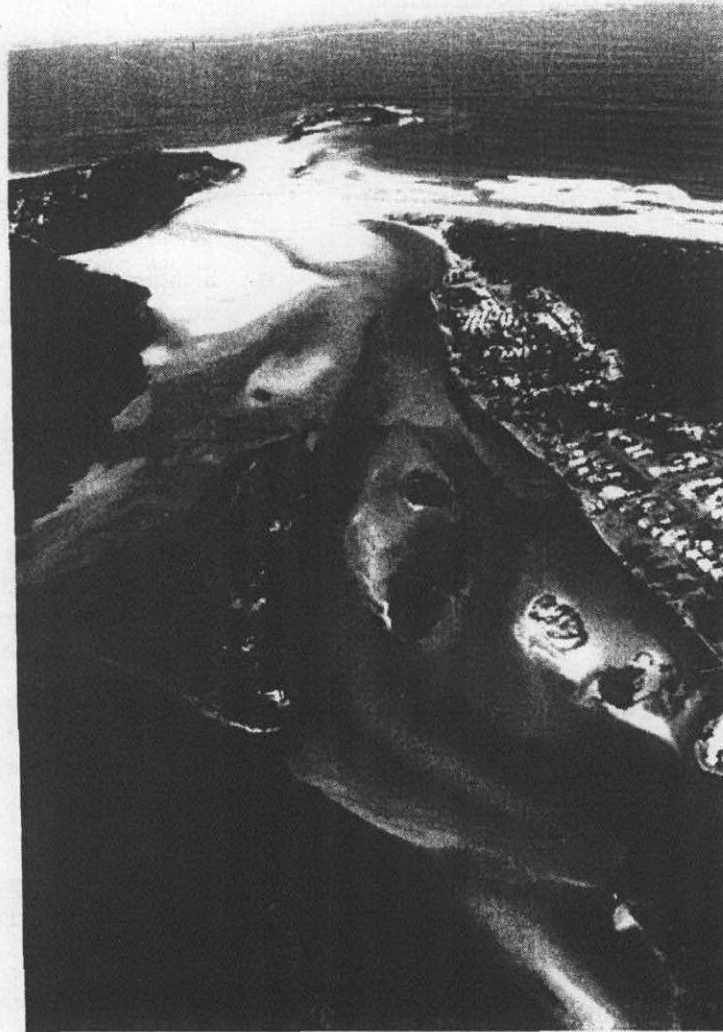
FIGURE 3 - LAKE CONJOLA ENTRANCE, JULY 1994

Figure 3 shows the main entrance channel completely infilled by the storm washover fan. Tidal flows through the shallow, choked secondary channel were insufficient to maintain the entrance which closed towards the end of 1994.

In Technical Appendix 11; Analysis of 1994-1998 Entrance Closure, it is demonstrated that the entrance closure was triggered by an extensive washover fan which occurred during the severe storm of March 1994.

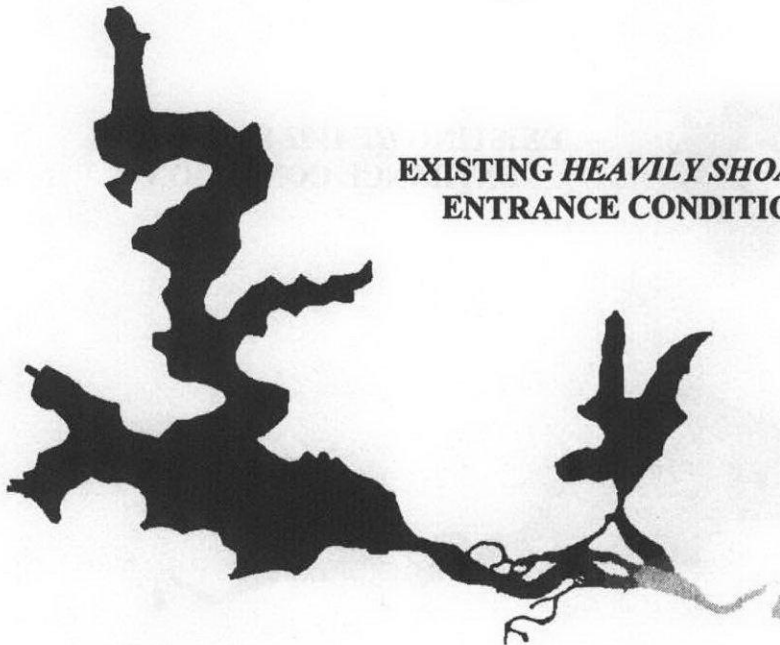
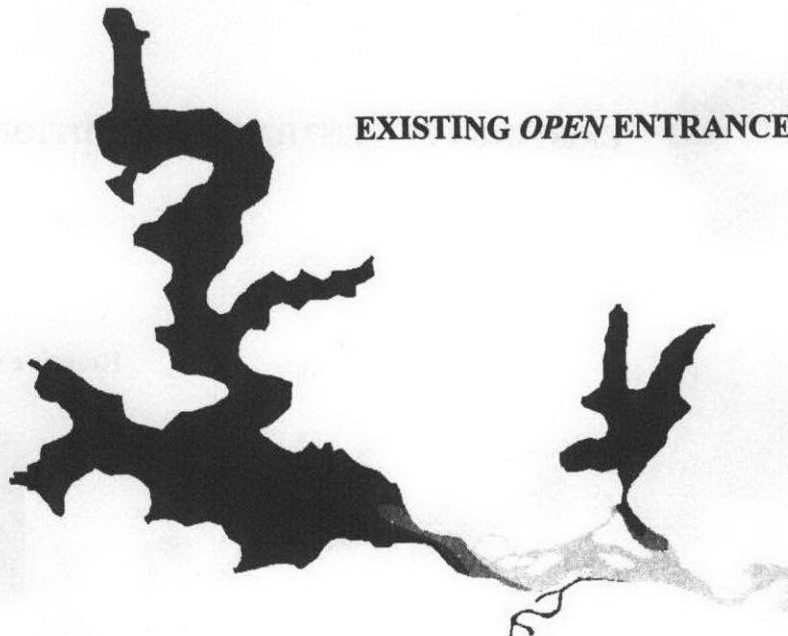
EXISTING *CLOSED* ENTRANCE CONDITION

EXISTING *HEAVILY SHOALED* ENTRANCE CONDITION

EXISTING *OPEN* ENTRANCE CONDITION

- 80 - 100% flushed
- 60 - 80% flushed
- 40 - 60% flushed
- 20 - 40% flushed
- 0 - 20% flushed

When the entrance is open, the inlet from the mouth to Conjola Island is 80-100% flushed and 60-80% from Conjola Island to "the steps". Lake Berringer is approx 30-40% flushed. Apart from a tongue extending along the northern shore to Station Point, the main body of Lake Conjola is
