Lake Conjola

Summary of OH&S Treats and Risks Assessment

February 2019

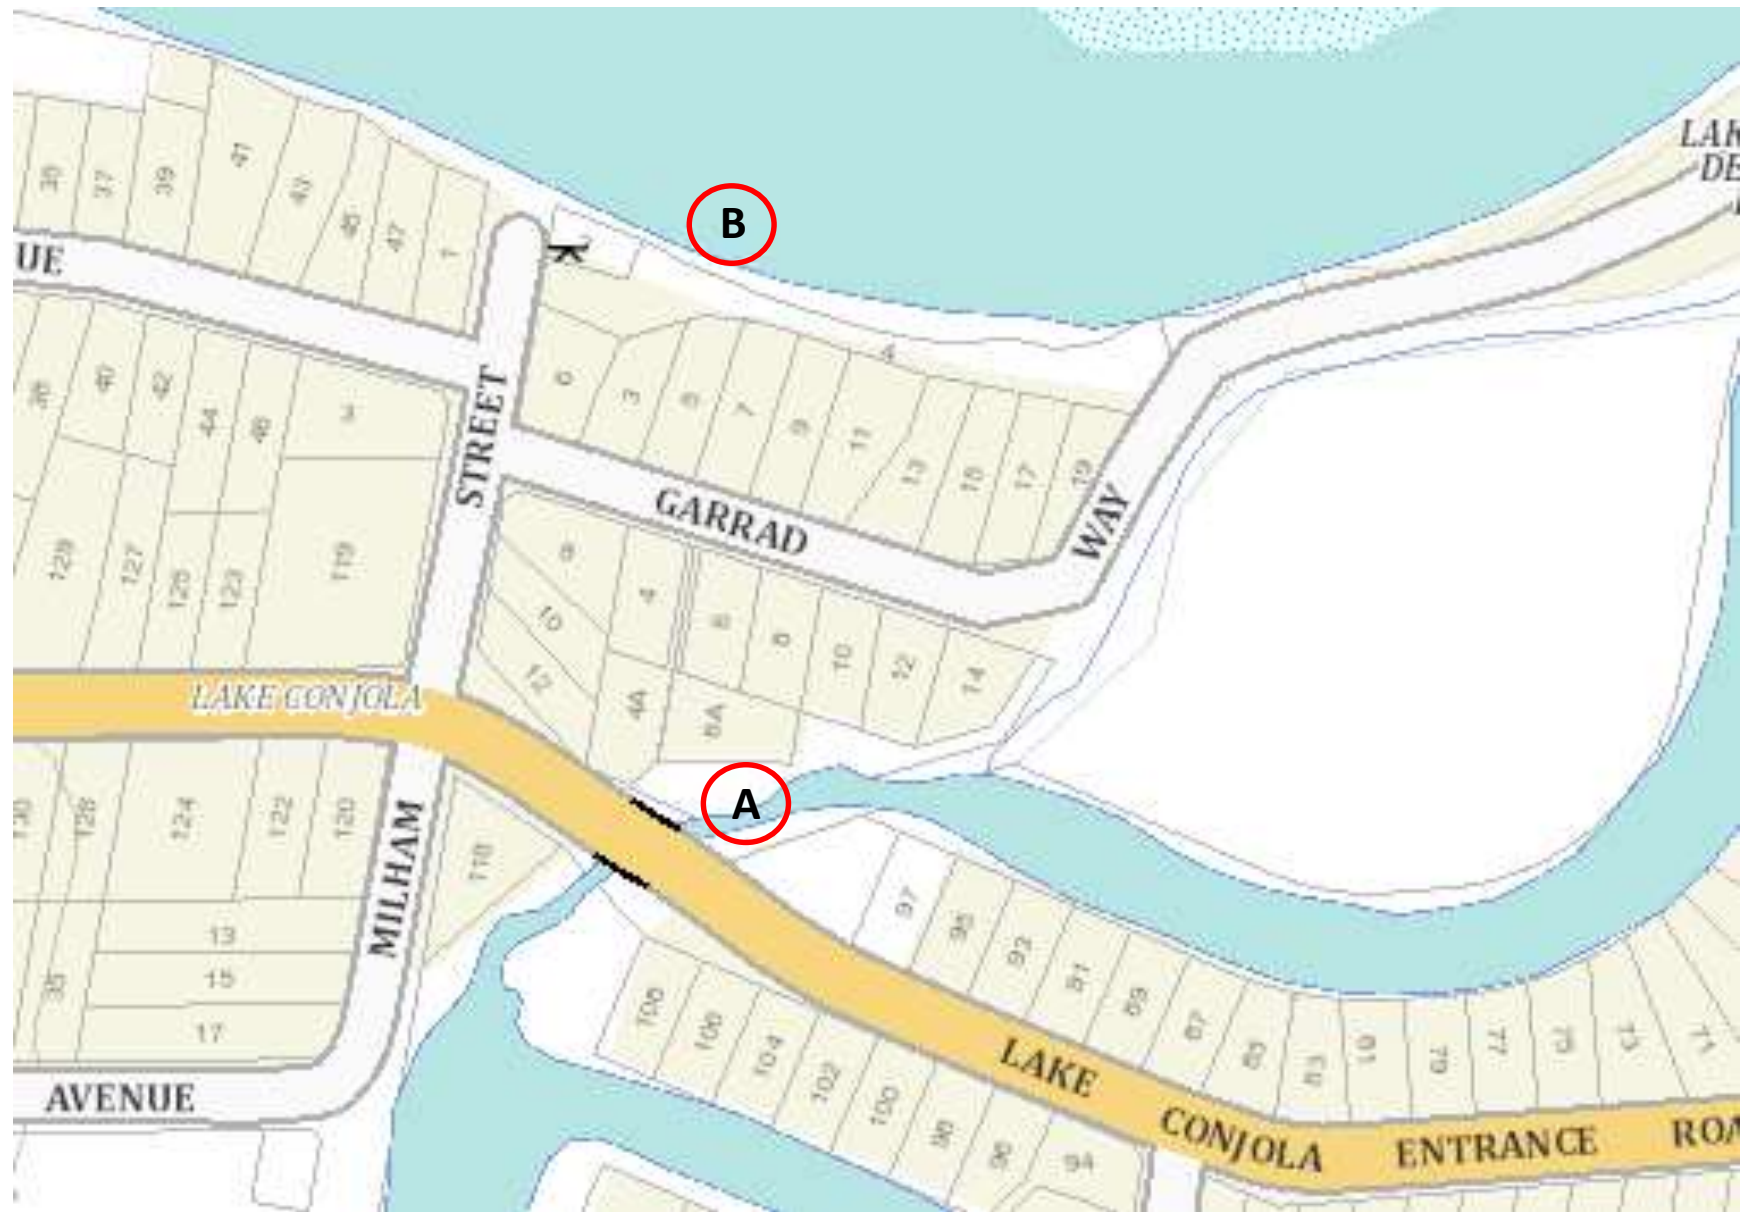
Table 1.4 – Summary of Foreshore Threats and Risks as at 09.02.2019

- ... 5.907km of public and private foreshore partially or fully inundated
- ... Above includes 1.53km of partially or fully submerged rock seawalls
- ... Beach profile throughout entire Lake (with the exception of Killarney Point) submerged with no easy access
- ... Increased concentration of water skiing / wakeboarding craft at this location
- ... 37 public and private jetties/slipways partially or totally submerged
- ... 12 public and private boat ramps partially or fully submerged – all slippery from alga and/or wave overtopping
- ... 2 remnant oyster lease structures partially submerged in navigable channels
- ... 6 recently fallen significant trees added to waterway
