## **Shoalhaven City Council**

Lake Conjola Entrance  
Management

Discussion Paper

January 2012

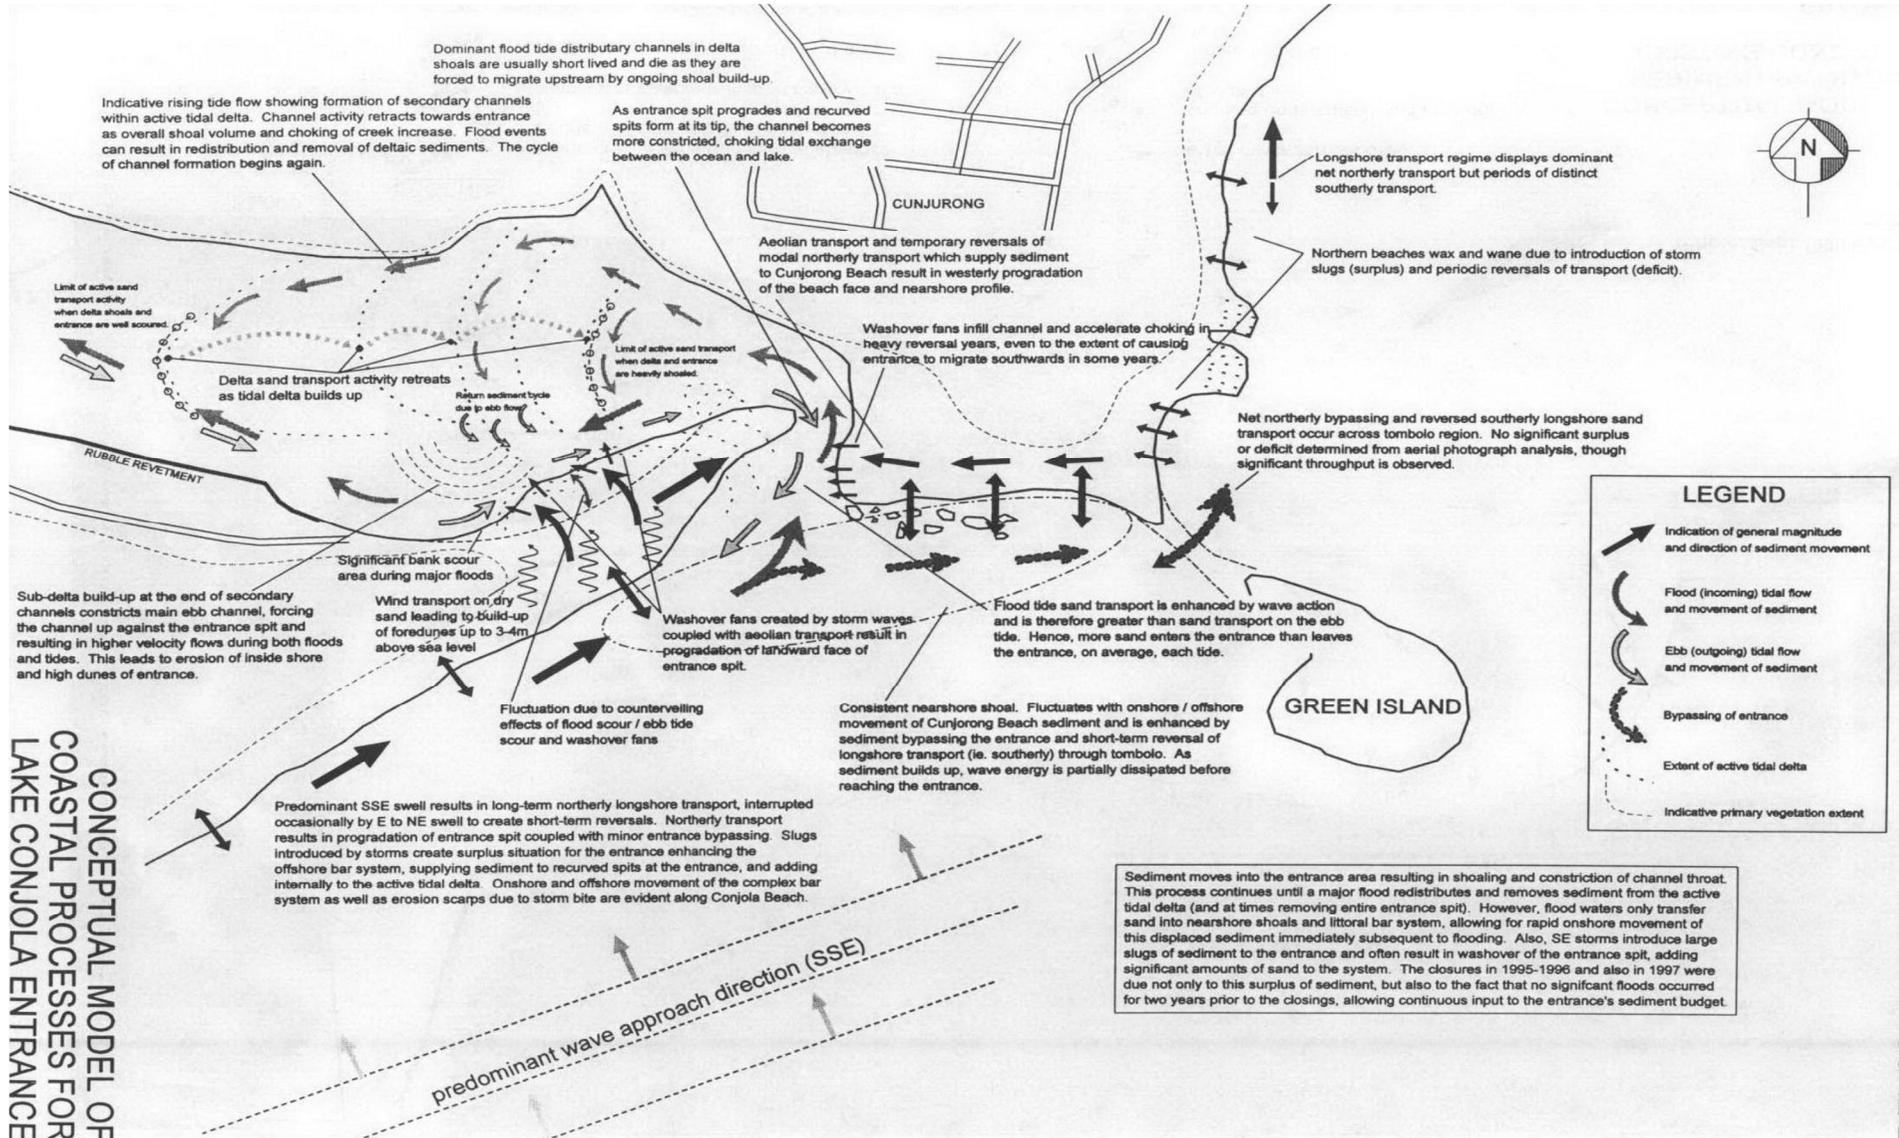
Figure 2 Conceptual Model for Coastal Processes for Lake Conjola (PBP 1999)

CONCEPTUAL MODEL OF COASTAL PROCESSES FOR LAKE CONJOLA ENTRANCE

Entrance behaviour is a complex process due to the unpredictable nature of coastal processes acting to infill the entrance with beach sand and fluvial processes resulting from rain acting to scour sand out of the entrance as is depicted in Figure 2. Shoalhaven City Council undertook a study in 1996 and Patterson Britton and Partners (PBP) undertook investigations into the sensitivity of the lake entrance in 1999 as presented in the *Lake Conjola Entrance Study* in order to improve understanding of the complex entrance behaviour.
